Methodology to carry out an analysis of damage caused by wear of blades of axial compressor on a marine gas turbine

DOI: 10.35429/JOTI.2021.15.5.1.7

Citation: VILLAGRÁN-VILLEGAS, Luz Yazmín, SIORDIA-VÁSQUEZ, Xóchitl, PATIÑO-ORTIZ, Miguel and VELÁZQUEZ-MARTÍNEZ, Víctor. Methodology to carry out an analysis of damage caused by wear of blades of axial compressor on a marine gas turbine. Journal of Technical Invention. 2021. 5-15:1-7

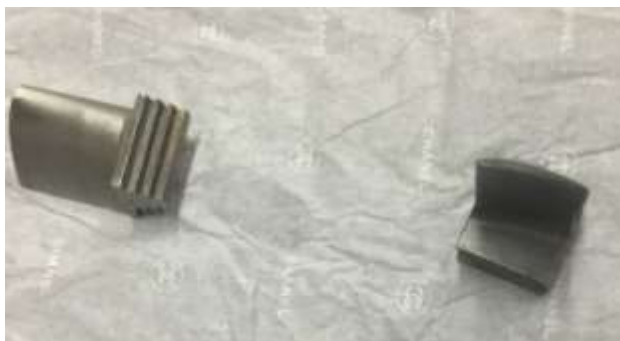
Figure 3 7th. Stage's blade, Rotor Axial Compressor

A study of wear damage of a seventh-stage's blade of axial compressor of a gas turbine (see Figure 3) was carried out. Manufacturer recommends routine maintenance at 30,000 hours to reduce chances for shutdown of gas turbine. In this study, the C40 gas turbine at 24,000 hours (shutdown) in field and out of service after 30,000 hours was analysed. This gas turbine was operating in Campeche City, Mexico (see Table 2), in a very aggressive environment, where entry of solid particles is unavoidable.

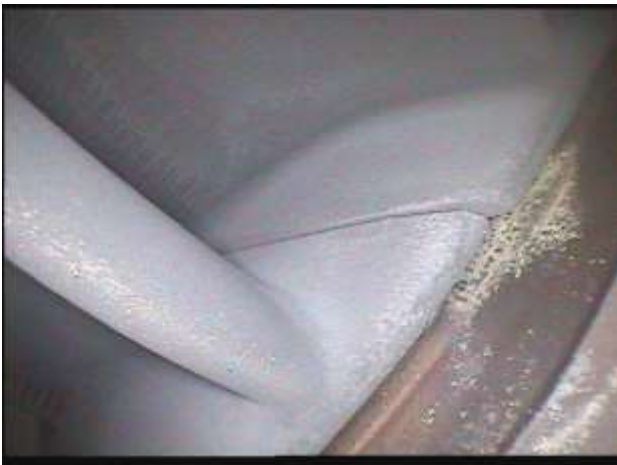
Figure 6 Boroscope test (24,000 hours)

In Borescope analysis, contamination in first stage of axial compressor was observed, it is a mixture of oil vapours that can prevent variable blades from opening or closing, which can lead to a low turbine performance and, even serious damage to turbines. The stage seventh of axial compressor has impregnated with dirt and debris, which is usually detergent and water used for washing of axial compressor's rotor (Figure 6), but this routine activity of maintenance is annual and technical engineer only carries out chemical analyses of water to detect metals in samples. In fact, his drag of solid particles by gas flow is another major problem during the operation of turbines. These foreign particles can either be deposited over turbine trail and blades (see Figure 1), causing wear and reducing efficiency of the turbine, or be launched at high velocities against blade surfaces, promoting formation of erosion pits in preferential areas, which can act as stress raisers [9–10].

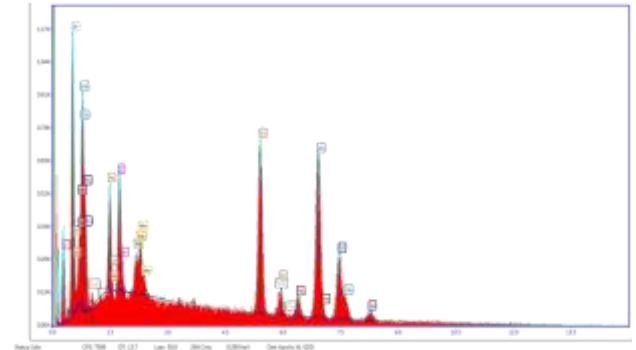
Figure 7 Chemical compositions used EDS

Energy dispersive X-ray (EDS) to obtain chemical composition was used. Chromium, Iron, Nickel and Carbon were detected and obtain quantitative analysis by Atomic Absorption Spectroscopy: chromium 17.9%, nickel 11.4%, molybdenum 0.01% and silicon 0.88%.

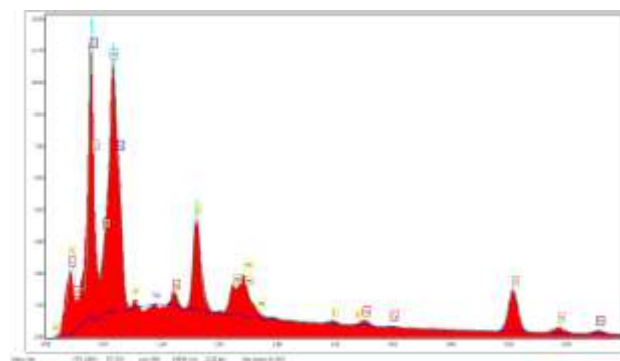
Figure 11 Chemical analysis in trailing edge 8 chemical elements and EDS graph

Elements such as cobalt (Co), nickel (Ni), niobium (Nb) and molybdenum (Mo), with exception of Ni, these elements and weight percentages are close to martensitic stainless-steel compositions [9].

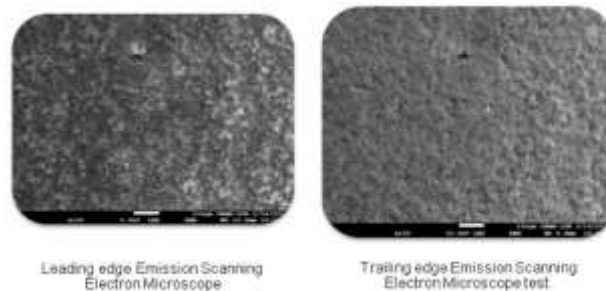
Figure 12 Worn region with 3KV and 15 KV (JEOL JSM-7600 SEM)

In worn regions with 3KV and 15 KV (Figure 12) showed different elements than those observed in worn surface. In zones 1 and 2 (Figure 13), new chemical elements appeared in EDS analysis such as carbon (C), oxygen (O), aluminum (Al), silicon (Si), niobium (Ni), molybdenum (Mo), chromium (Cr), iron (Fe), cobalt (Co) and nickel (Ni) and when applying 15 KV new chemical elements appeared in EDS analysis such as carbon (C), oxygen (O), aluminium (Al), silicon (Si), potassium (K), calcium (Ca), titanium (Ti) chromium (Cr), manganese (Mn), iron (Fe), cobalt (Co), nickel (Ni), Tungsten (W), niobium (Ni) and molybdenum (Mo), which could be due to introduced particles (contaminants) travelling in air intake or from hot corrosion (accelerated oxidation damage) due to corrosive deposits. There is evidence of aluminum, chromium and iron oxides in this region [12–13].

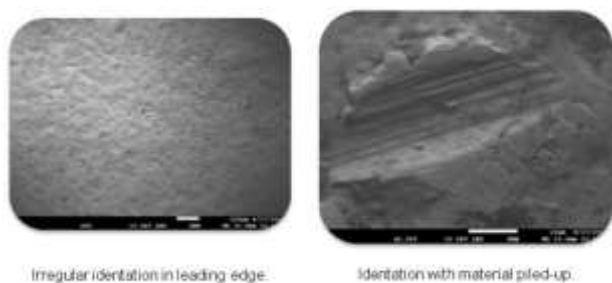
Figure 14 Irregular indentation and material piled-up (trailing edge)

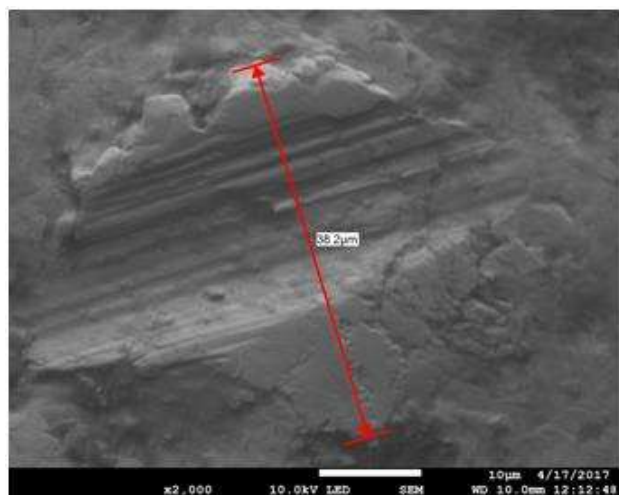
Figure 15 Cavity around 38.2 μm.

Figure 16 in trailing edge, present irregular indentations were identified on surfaces around 176–268 μm length with material piled-up (lips) at sides and cavity around 38.2 μm (see Figure 15), the result of subsequent particle impacts, which caused detachment of lips with trajectory around 408–648 μm.

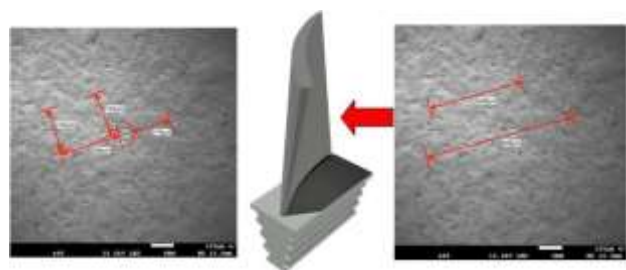
Figure 16 Trailing edge (Emission Scanning Electron Microscopy test)

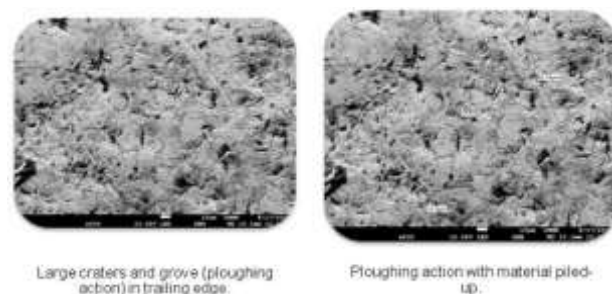
Figure 17 Trailing edge (Emission Scanning Electron Microscopy test)

Images in Figures 17 and 18 in leading edge, which are characterized by large craters and grooves (ploughing action) of around 125–150 μm length with material piled-up (lips) at sides around 4.7–15.2 μm length and in front of cavities, which is common in solid particle erosion, as specimens are impacted at oblique incident angles ($\alpha \leq 45^\circ$) [14].

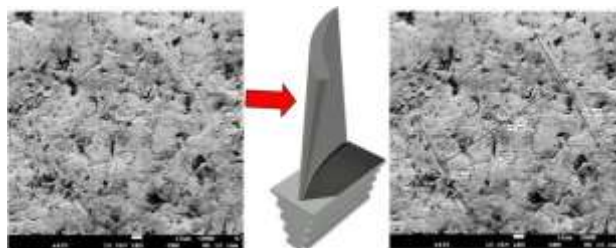
Figure 18 Leading edge (Emission Scanning Electron Microscopy test)
