## Modeling compressor blades gas turbine in a marine environment to determine of the stress and possible damages

In this paper, the static simulation carried out on the blades of the seventh stage of the compressor of a gas turbine installed in an offshore oil platform is reported, the objective of this simulation is to have a means of analysis that confirms and complements the tests visual inspection (boroscopy), as well as non-destructive tests. In specific case of this compressor, the results of boroscopy were available, as well as the scanning electron microscope (SEM), with which it was possible to measure the roughness and evaluate the degradation of the blade surfaces after 30,000 hours of service operating in Cantarell, Mexico, in a very aggressive marine environment conditions, where the entry of solid particles is highly possible. The model of seventh stage's blade was obtained with a cloud of points. A finite element analysis was carried out with ANSYS software. Results showed wear modes were originated by a severe stinging action. Also, large craters, similar to those observed in solid particle erosion, were developed by at normal impact. The points, where peak stress

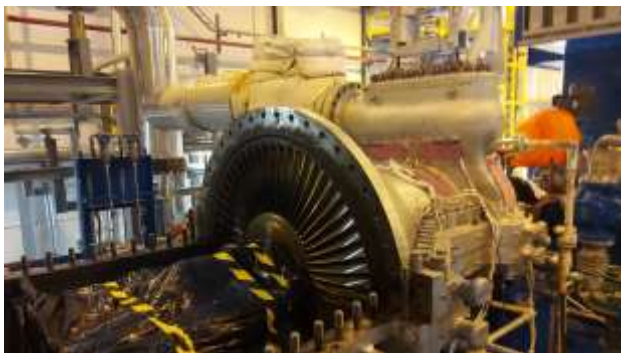
**Figure 1** Blade rotor of compressor gas turbine  
*Note. Adapted of Compressor turbine disk, Villagrán-Villegas Luz Yazmin, 2017*

A study of wear damage of a seventh-stage's blade of axial compressor of a gas turbine (see Figure 1) was carried out. Manufacturer recommends routine maintenance at 30,000 hours to reduce chances for shutdown of gas turbine, but the C40 gas turbine shutdown at 24,000 hours in field and out of service after 30,000 hours. In this study an analysis was made to model through computational dynamics the efforts to which it will be subjected and anticipate the operation shutdown time. [2].

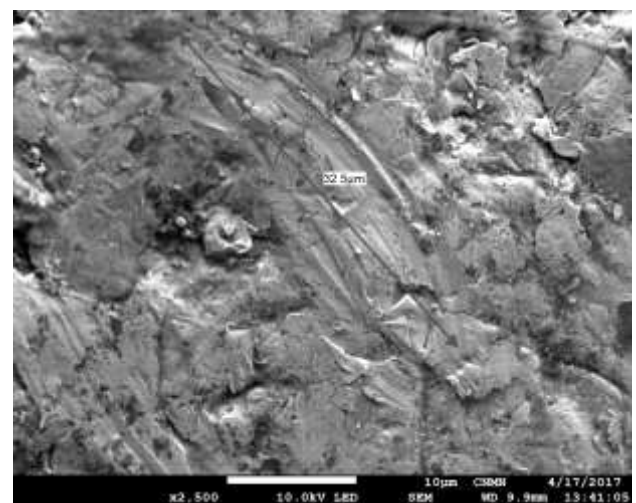
**Figure 2** Irregular indentation and material piled-up (trailing edge)

At the second step could, the analysis showed the degradation of surfaces in areas of higher air pressure mixed with particles, that it is hoped it can be confirmed in the modelling. In this phase of scanning, two techniques to preparation of the sample were used, first one analysis in trailing edge and then leading edge of the piece (Figure 2).

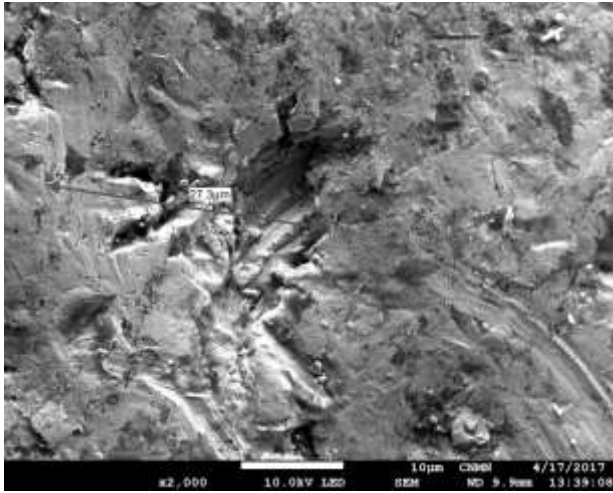
**Figure 3** Trailing edge (Emission Scanning Electron Microscopy test)

Figure 3 in trailing edge, present irregular indentations were identified on surfaces around 27.3  $\mu\text{m}$  length with material piled-up (lips) at sides as the result of subsequent particle impacts, which caused detachment of lips with trajectory around 32.5  $\mu\text{m}$ .

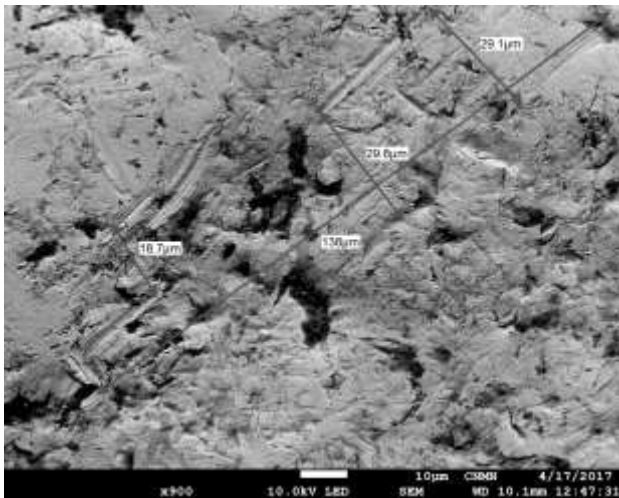
**Figure 4** Leading edge (Emission Scanning Electron Microscopy test)

Images in Figure 4 in leading edge, which are characterized by large craters and grooves (ploughing action) of around 0–138  $\mu\text{m}$  length with material piled-up (lips) at sides around 4.7–15.2  $\mu\text{m}$  length and in front of cavities, which is common in solid particle erosion, as specimens are impacted at oblique incident angles ( $\alpha \leq 45^\circ$ )

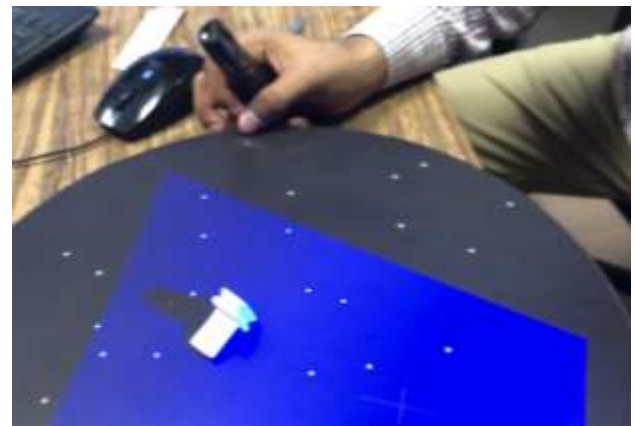
Piece evaluated with blue light of ATOS scanner is a compressor vane of 7th stage, which when mounted on turntable, a point cloud is obtained. Data acquisition procedure (Figure 5) requires that the piece is coated with a white paint film (zinc oxide), for this testing stage the piece was already evaluated in RX and SEM.

**Figure 5** 3D digitization process of blade. Note: Adapted "Study of wear damage in compressor turbine blades"(p. 76), Villagrán-Villegas L. , 2017

At the end of the process, a dot grid of axial compressor blade was obtained, one mesh with 93508 nodes (points). The model was optimized with GOM software and the model was reduced to 19938 nodes, which helps to optimized processing time.

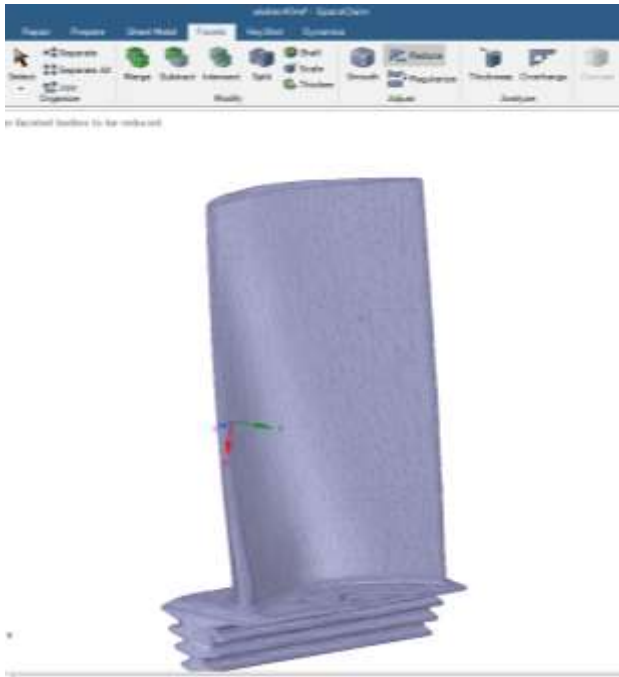
**Figure 6** Model optimized with GOM software
