Methodology to carry out an analysis of damage caused by wear of blades of axial compressor on a marine gas turbine

DOI: 10.35429/JOTI.2021.15.5.1.7

Citation: VILLAGRÁN-VILLEGAS, Luz Yazmín, SIORDIA-VÁSQUEZ, Xóchitl, PATIÑO-ORTIZ, Miguel and VELÁZQUEZ-MARTÍNEZ, Víctor. Methodology to carry out an analysis of damage caused by wear of blades of axial compressor on a marine gas turbine. Journal of Technical Invention. 2021. 5-15:1-7

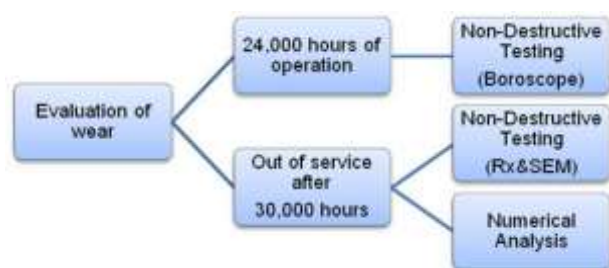
Figure 5 Evaluation of wear

Borecope test is a primary diagnostic method for turbo machinery maintenance; it is an inspection test that includes notification of the condition of equipment and effective programming of any necessary maintenance intervention. C40 gas turbine has four ports, where borescope can be introduced (Figure 5). Internal inspections are necessary to determine if wear or thermal erosion is present. Additionally, these inspections will take into account any damage caused by the impact of foreign objects (FOD), or if corrosion has occurred, and allow internal components to be assessed for thermal deterioration, fractures or distortion.

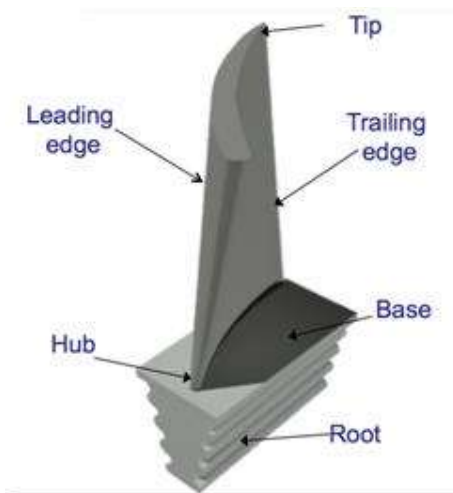
Figure 8 Parts of blade: leading edge, trailing edge, root, base and hub

A backscattered electron detector (BED) and Emission Scanning Electron Microscopy (JEOL JSM-7600F) to obtained SEM images were used. Tests were carried out to blade in leading and trailing edge (Figure 8) with field emission (show in Figure 9). In worn zone, 10 kV were applied and fourteen elements were found, such as chromium (Cr), nickel (Ni), molybdenum (Mo) and niobium (Nb). Percentages varied when evaluating a leading edge and another side, as shown Figure 9, but in analysis it was possible to identify the type of super alloy with 14 chemical elements in its composition.
